**CANADIAN FORCES
FLIGHT SAFETY INVESTIGATION REPORT (FSIR)**

FINAL REPORT

FILE NUMBER: 1010-114006

AIRCRAFT TYPE: CT-114 Tutor

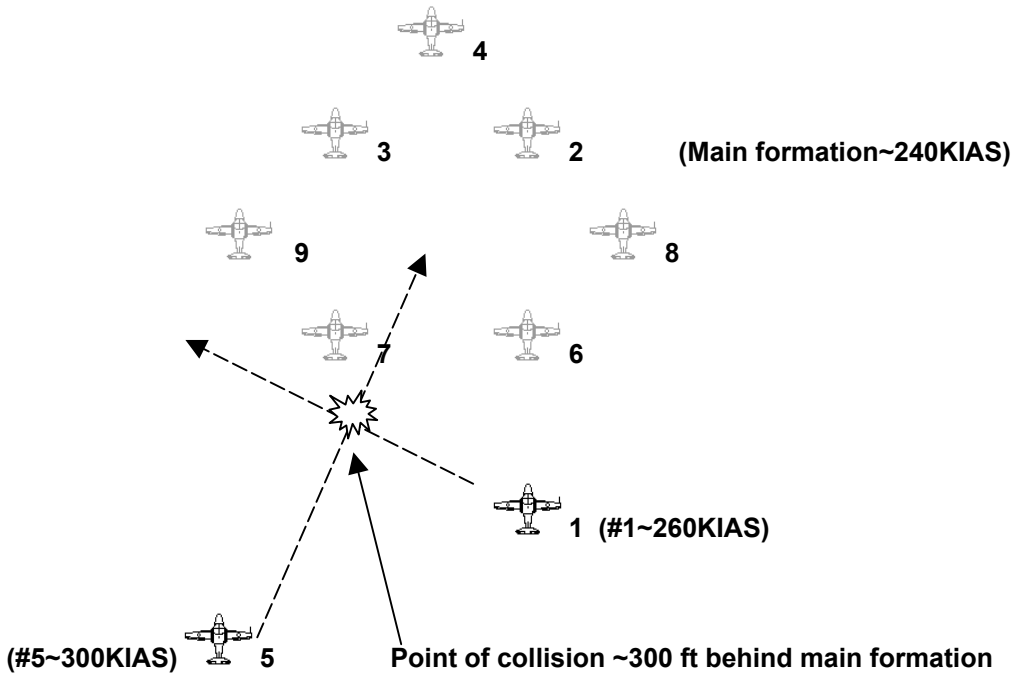
Figure 4

main formation up and into aircraft #1 where pilot #1 would again resume lead of the main formation. There were no radio transmissions made during this portion of the rejoin. Aircraft #5 was simultaneously continuing in towards the main formation on his extended rejoin line at approximately 300 knots indicated airspeed (KIAS). As aircraft #1 passed approximately 250-300 feet to the rear and crossing the approximate seven o'clock line of the main formation at approximately 260 KIAS, aircraft #1 and #5 collided (Figure 4).

The two aircraft collided at approximately the seven o'clock position and 250-300 feet behind the main formation (see Figure 4). Impact marks were taken from aircraft #5, which landed safely, and aircraft #1, which was recovered from the bottom of Lake Erie, and matched to determine angles of impact between the two aircraft. Based on witness testimony and impact marks, it was determined that, at the time of collision, the angle between the longitudinal axes of the two aircraft was approximately seven degrees (Figure 5). Aircraft #1 was also banked at approximately thirty degrees to the right relative to aircraft #5. The right trailing edge of aircraft #1 impacted the right leading edge of aircraft #5. A portion of the right aileron of aircraft #1 was found stuck in the right leading edge of aircraft #5 (Annex A, Photo 5). Considerable damage was caused to the right wing aileron of aircraft #1, causing the loss of control that pilot #1 experienced. The underside of the rear fuselage of aircraft #1 scraped along the top of the right wing of aircraft #5 causing gouge marks to both aircraft.

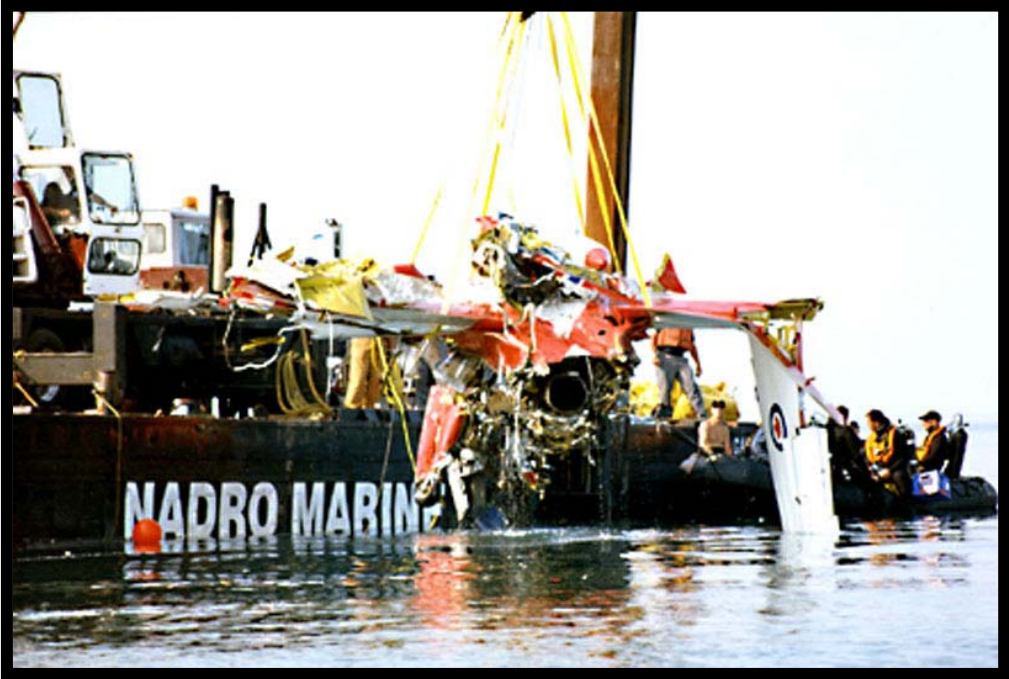
Aircraft #1 sustained "A" category damage. The right wing trailing edge was damaged to the extent that aircraft aileron control was lost when it impacted the right wing leading edge of aircraft #5 during the mid-air collision. A post ejection fire caused some fire damage primarily to the skin aft of the cockpit area. The aircraft was subsequently destroyed on water impact (Annex A, Photo 1).

Photo 1 – Wreckage of 114006 as pulled out of Lake Erie

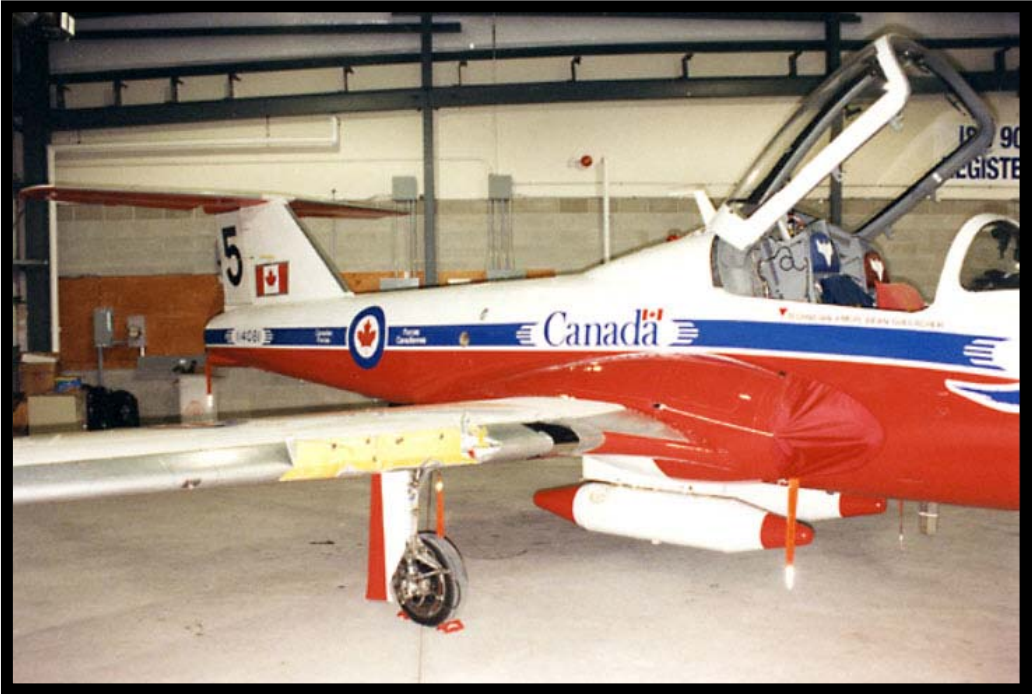
Aircraft #5 sustained "C" category damage. The right wing leading edge was damaged when it impacted the right wing trailing edge of aircraft #1. A portion of this leading edge was missing and numerous scratches and dents were found on the upper surface of the wing (Annex A, Photo 2, 3 and 4). The right hand aileron was bent and scratched at the outboard attaching point. Wiring was broken and pitot and static lines were damaged in the right wing leading edge. Although affected by this damage, control of aircraft #5 was maintained and the aircraft was flown to a safe landing.

Photo 2 – 114081 showing damaged right leading edge

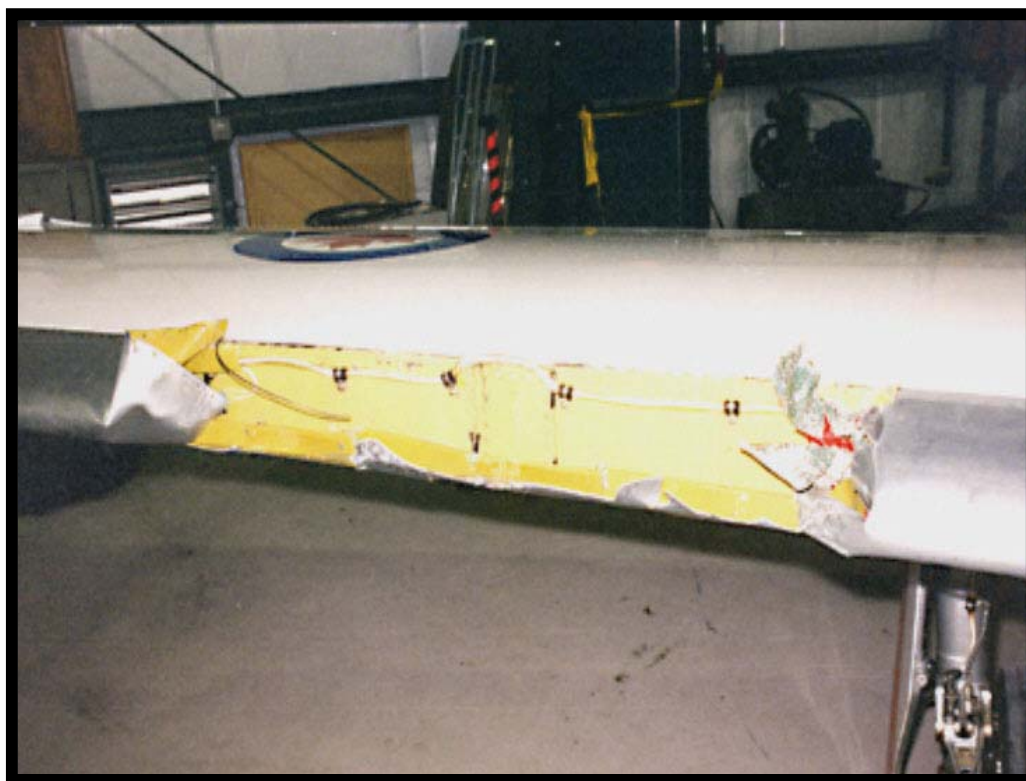
Photo 3 – 114081 closer view of damaged right leading edge

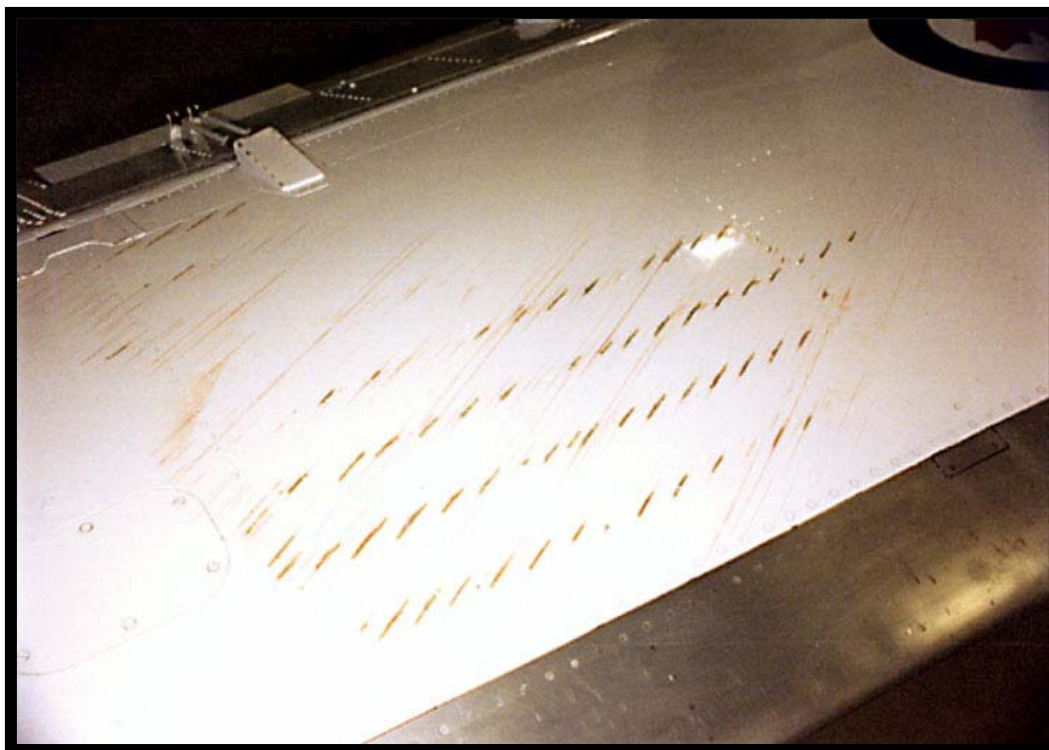
Photo 4 – 114081 Top of right wing

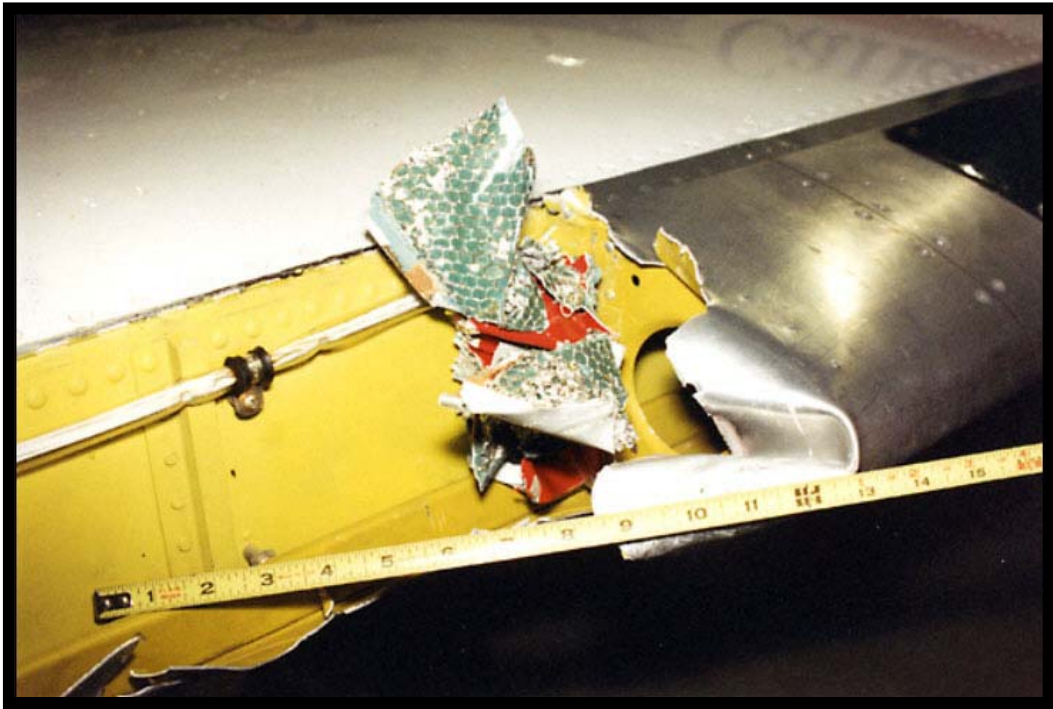
Photo 5 – Portion of 114006 right trailing edge embedded in right leading edge of 114081
